**DEPARTMENT OF TRANSPORTATION**

Contract #: 04-0120F4Cty: SF/ALA Rte: 80 PM: 13.2/13.9File #: 1.28**WELDING INSPECTION REPORT****Resident Engineer:** Casey, William**Address:** 333 Burma Road**City:** Oakland, CA 94607**Report No:** WIR-027829**Date Inspected:** 23-Jun-2012**Project Name:** SAS Superstructure**OSM Arrival Time:** 700**Prime Contractor:** American Bridge/Fluor Enterprises, a JV**OSM Departure Time:** 1530**Contractor:** American Bridge/Fluor Enterprises, a JV**Location:** jobsite

**OBG W13-W14 Splice West Drop-in**

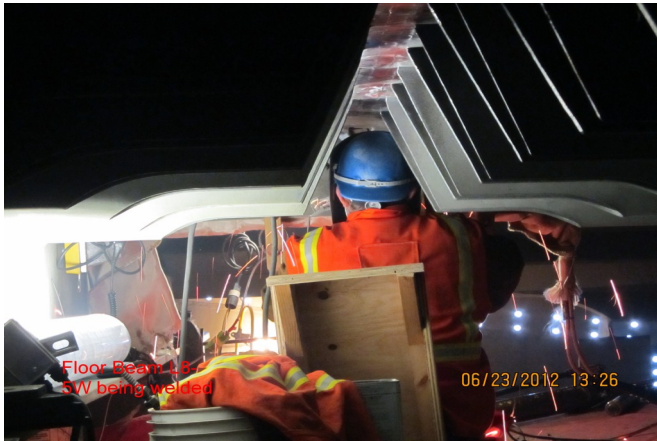
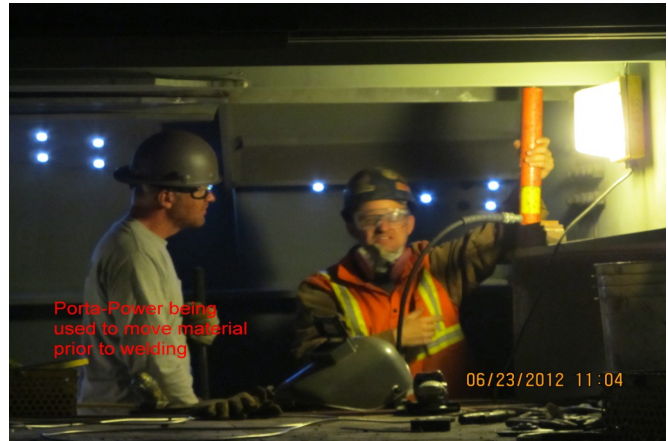
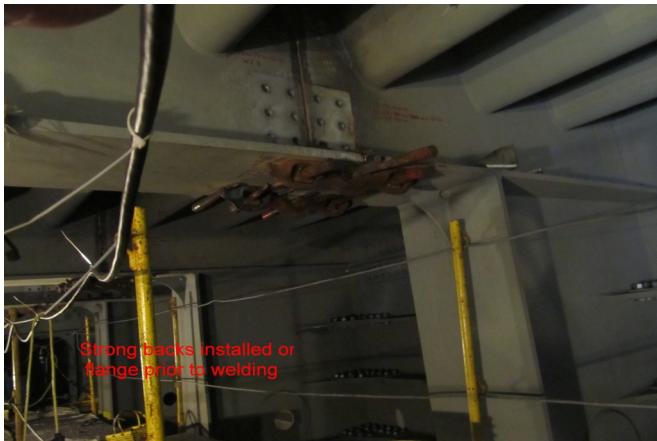
Numerous techniques are being used by the contractor to correct planer misalignment on the floor beams. One example is tack welding strong backs on to the beam flange and driving wedges to position the the material into

place for welding. (See pictures) Another method is to use a porta power hydraulic ram to reposition the flange then tacking strong backs followed by welding in the finished weld joint. (See pictures)
